**SALVAGE PLAN
USCG
Spirit of Sacramento Salvage**

Title: Spirit of Sacramento Salvage Plan

Location: False River near Bethel Island, CA

Scope of Work: Provide salvage services to parbuckle, raise and defuel capsized passenger vessel “Spirit of Sacramento”.

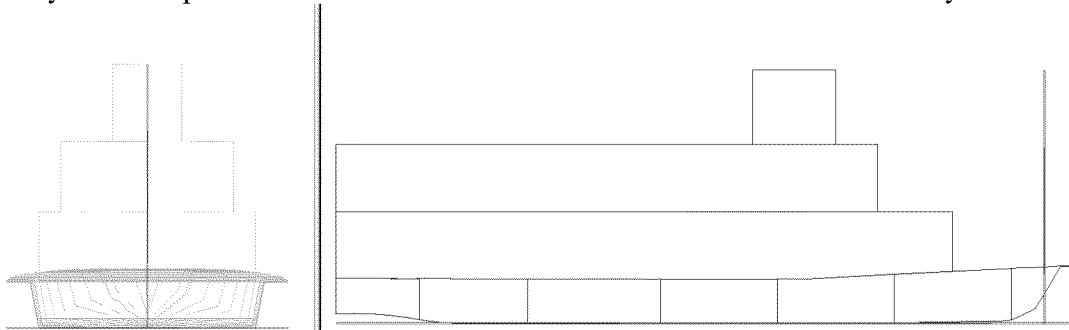
Figure 1: Geometry Model

The lines for the hull are taken from chine and edge deck lines as shown in various historical drawings for the vessel and then mapped to a similar hull form. The hydrostatics for model are with 5% of an SHCP report for the vessel, dated Nov'96. The main deck aprons were added to match the Thomas Wilson Dwg "Capacity Table & Structure Below the Main Deck", dated 1981. It should be noted that the hydrostatic model ends 85 feet aft of the forward perpendicular not including the apron. While there is likely some buoyant volume outboard of the paddle wheel, it is likely very small. The upper decks were added to the model with some dimensions taken from drawings and others estimated from photographs. Note also that the outboard extents of the deck house (particularly on the 02 deck) are important in estimating parbuckling forces, as such the uncertainty in deck house dimensions should be considered in reviewing the parbuckling analysis. Compartmentation was added the hull to match the latest stability letter.

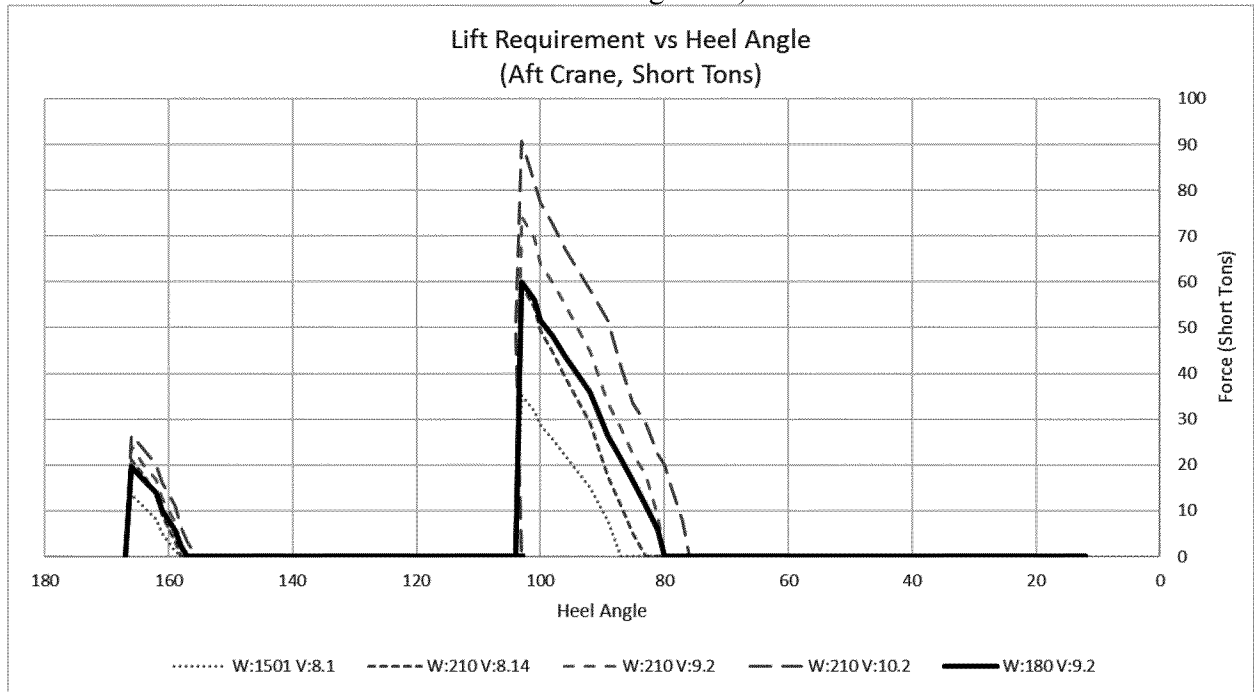
Figure 3: Parbuckling Analysis Results

Figure 3 shows the results of this analysis over the range of presumed displacement and VCGs. As expected, based on the model's geometry, the results show two distinct phases of the parbuckling operation. The first phase takes the wreck from its current condition to approximately 155° where it partially self-rights to sit on its side. The second phase takes the wreck from approximately 104° of heel to the next self-righting angle which varies based on VCG and weight between 87° and 76° of heel. In each case the final resting condition is approximately 12° of heel and 8° of trim by the stern, to match the assumed bottom slope. In general, the lift force requirements increase with both weight and VCG, making the 210 long ton and 10.2 ft VCG the worst case. Using these conservative assumptions, the maximum hook loads are 26 and 90 short tons in the 1st and 2nd phases, respectively. However, in our judgement, these assumptions are likely overly conservative, and using our best estimate of the vessel's actual weight and VCG, the maximum hook loads are actually 20 and 60 short tons respectively. (Our best estimate case is shown in the solid black line in Figure 3.)

In order to estimate the crane forces required for parbuckling the wreck, an analysis was conducted which evaluated the forces required to rotate the model through the range of heel angles until approximately upright. Lift points were applied to the model, simulated as additional ground points. Based on the parbuckling rigging arrangements, the location of the lift points was altered as the model rotated. Initially the lift points were placed at the port deck edge of the 02 deck, fore and aft. The lift points were raised incrementally, and the required lift force was recorded. Note that because of the slope of the bottom and

associated trim in the model, it was only necessary to lift on aft lift points. When the model rotated to less than 130° of heel the lift point were shifted to the starboard deck edge of the 02 deck.

As mentioned previously, the breadths of the upper decks are not precisely known. We are more confident in the deck heights - which more directly govern the relevant moment arm. Still, there is some uncertainty in the parbuckling "pull points." Additionally, the bottom topography will also affect the parbuckling forces. Accordingly, there is some additional uncertainty with the results shown in Figure 3. However, given that the most conservative cases were still within the lift capacity of the intended cranes, the analysis still strongly suggests that the proposed cranes will be sufficient.

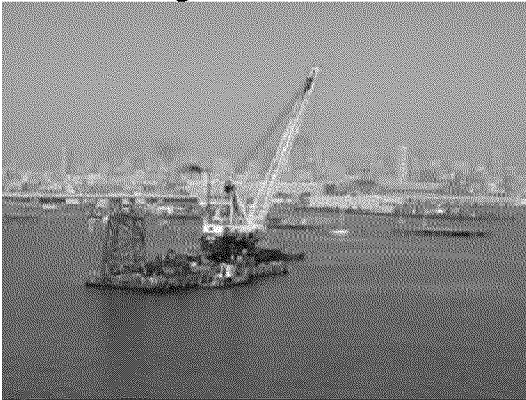
Derrick Barge #24

Barge
Built

F.M.C. - 1968 - Portland, OR
